# Proceedings of the 9<sup>th</sup> Water System Seismic Conference

October 14–16, 2015

Sendai, Japan

Project #4603

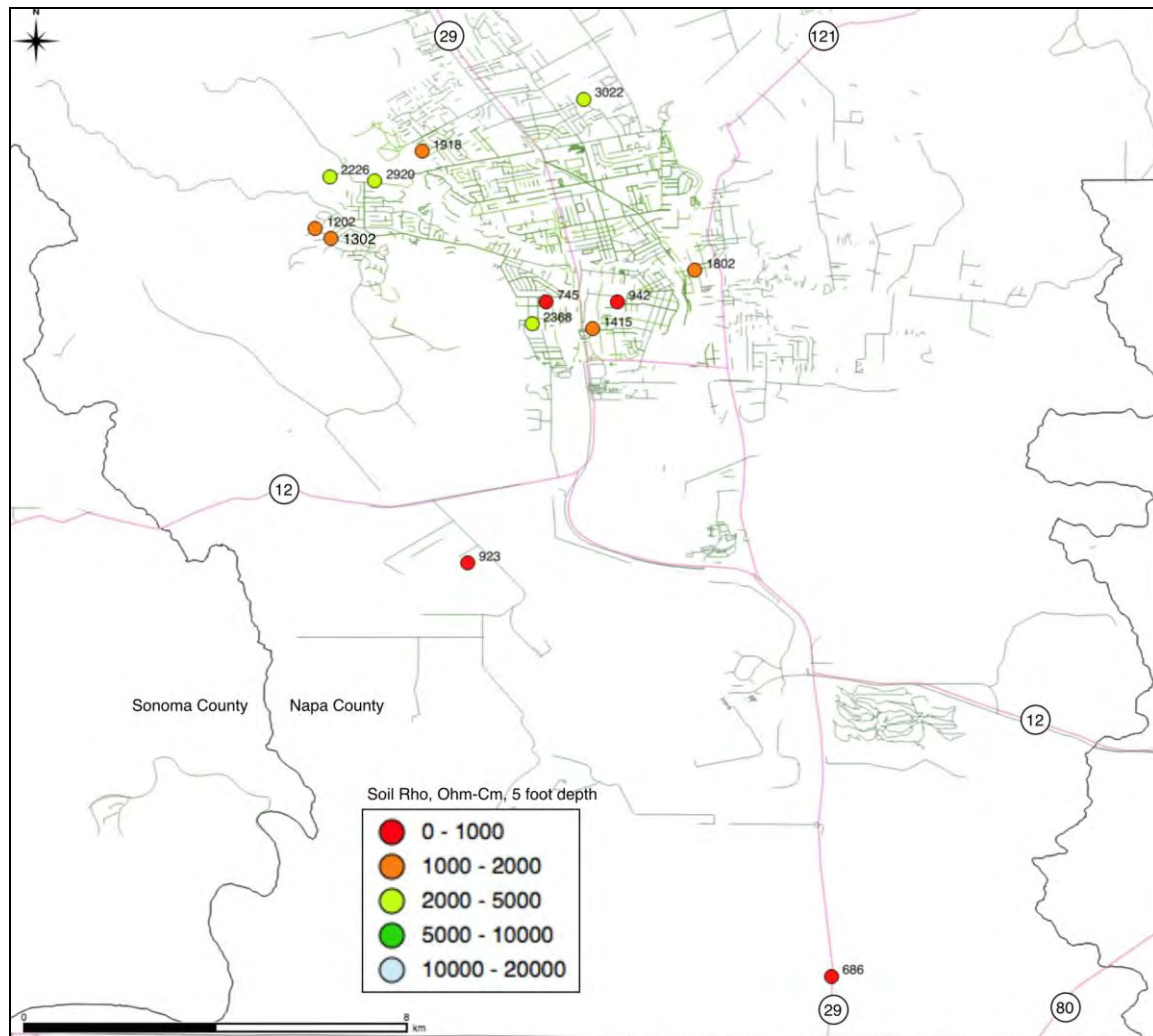
*Figure 3. Soil Resistivity and Location of Pipe Repairs for Napa Water Pipe*

Figure 3 shows that the soils in Napa are extremely aggressive. This may be in part due to the volcanic origins of the soils; many are clayey-in nature. At three test locations, Rho was under 1,000 ohm-cm (extremely corrosive); four more tests showed Rho from 1,000 to 2,000 ohm-cm (very aggressive); and four more tests showed Rho from 2,000 to 3,022 ohm-cm.

The Napa water department reports that their ductile iron pipe has had a fairly high leak rate, even without the earthquake, and this reflects that Napa apparently did not install polyethylene "baggies" over the ductile iron pipe. The very aggressive nature of the soils; coupled with the relatively thinner wall thickness of ductile iron pipe, under 0.5 cm (0.2 inches), relative older but thicker cast iron pipe that are commonly 1.27 cm (0.5 inches) or thicker.

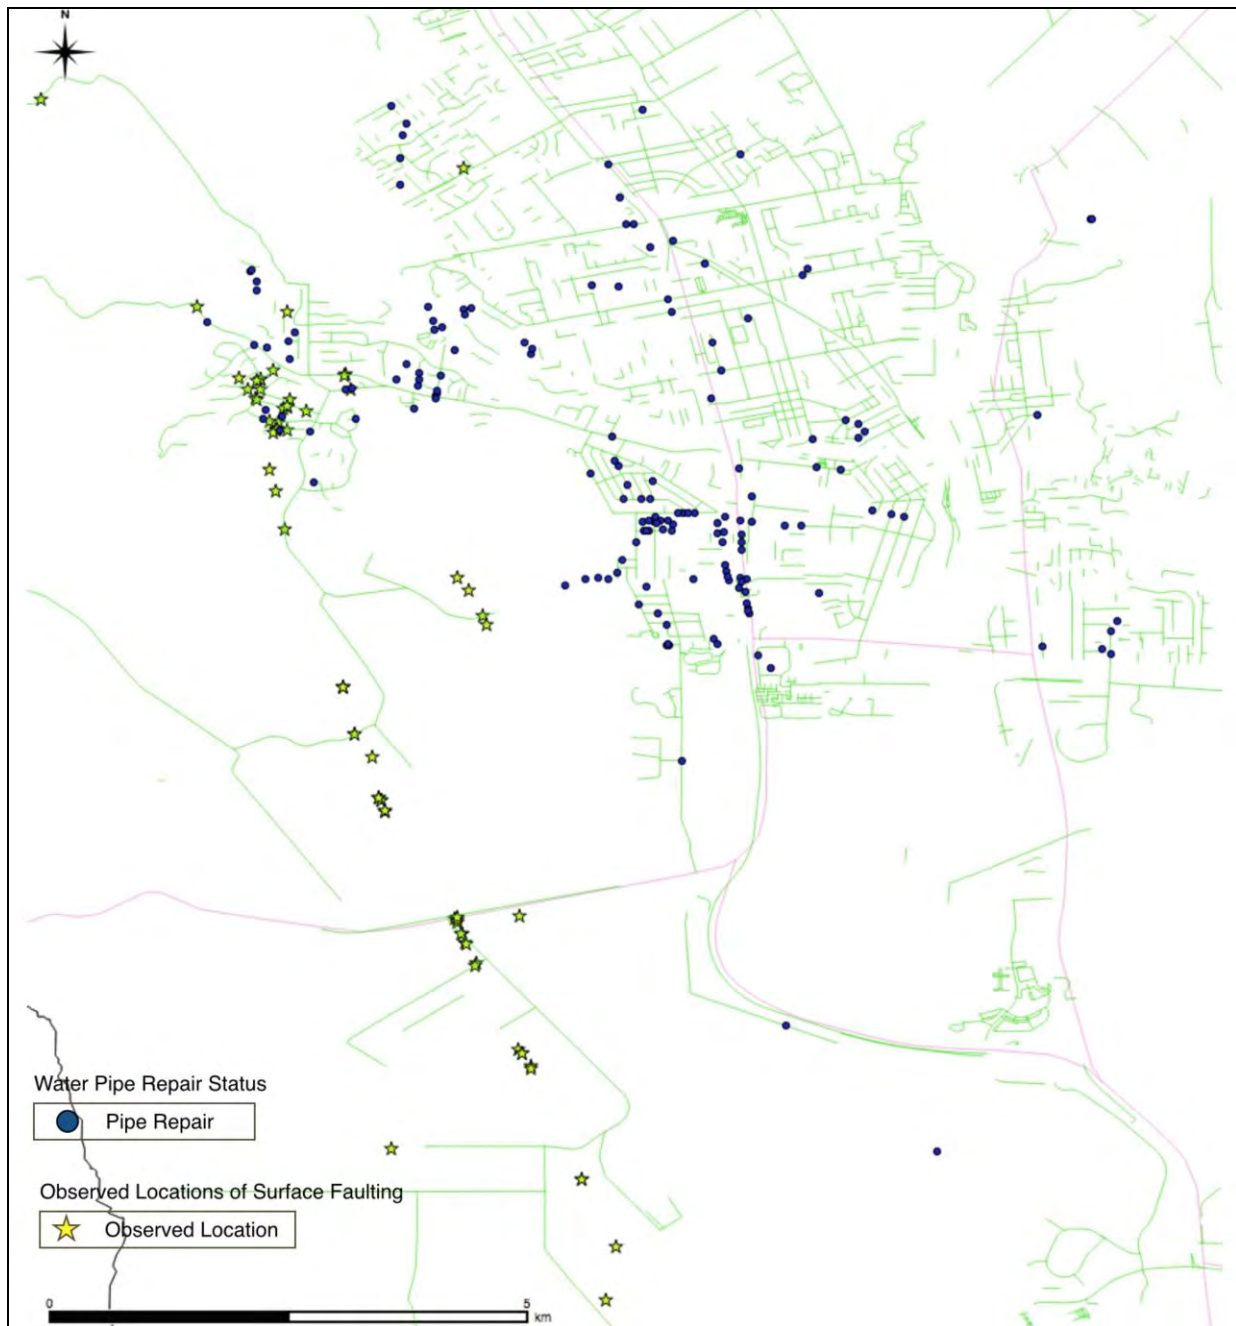
*Figure 4. Location of Surface Faulting and Water Pipe Repairs*

In the northwest part of the water system, there was surface faulting. Figure 4 (left) shows a map of the 71 locations with observed surface faulting (yellow stars), along with the pipe repair locations. The light green lines indicate streets; light blue lines indicate major roads / highways.

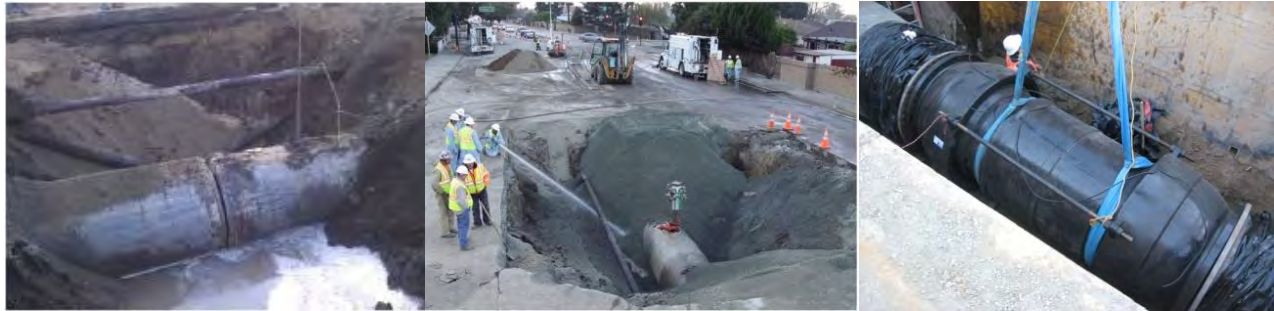
the roadway, adjacent utilities, and a creek bank. An adjacent 6-inch diameter petroleum product line operated by the Conoco Phillips Pipeline Company was damaged as well. The petroleum line had to be shut down and repaired prior to EBMUD crews being able to start repairs on the transmission main, which increased recovery time. Figure 5 shows the large sinkhole created by this break, with both the 60-inch (1.5-meter) pipe (seen in foreground) and 6-inch (0.15-meter) petroleum pipe exposed (in background). EBMUD was able to avoid any level of service impacts associated with this break by relying on an adjacent 24-inch (0.6-meter) diameter High Density Polyethylene (HDPE) bypass pipeline that had been installed at this location in 1997, as part of EBMUD's Seismic Improvement Program.

**Figure 5. El Portal Main Break/Sinkhole and Mitigation Project  
Example of Cascading Failures Associated with Collocated Utilities**

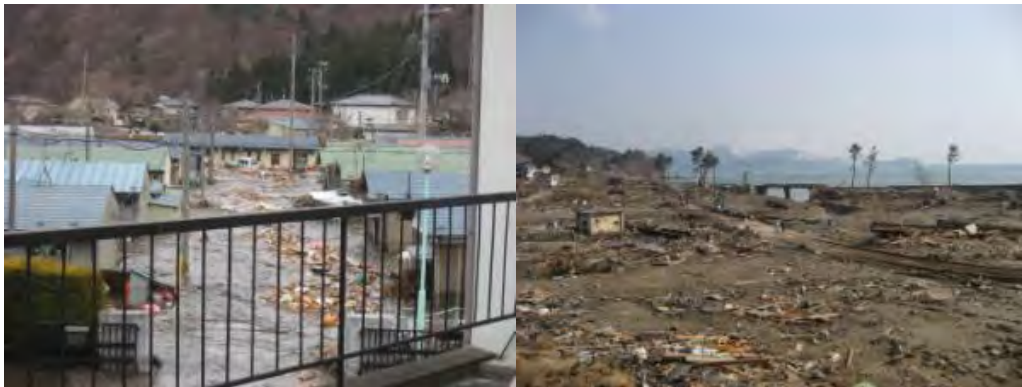
Figure 4 Damage to (left) the water purification plant and (right) the Namiita pumping station .

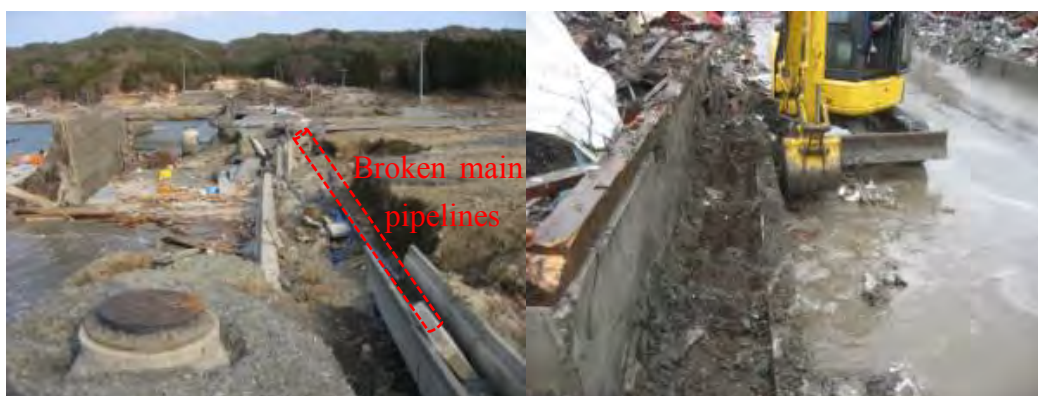
Figure 5 Damage to the pipelines. (left) Broken main pipelines near the coast was washed away and (right) a damaged stop valve with water flowing out.

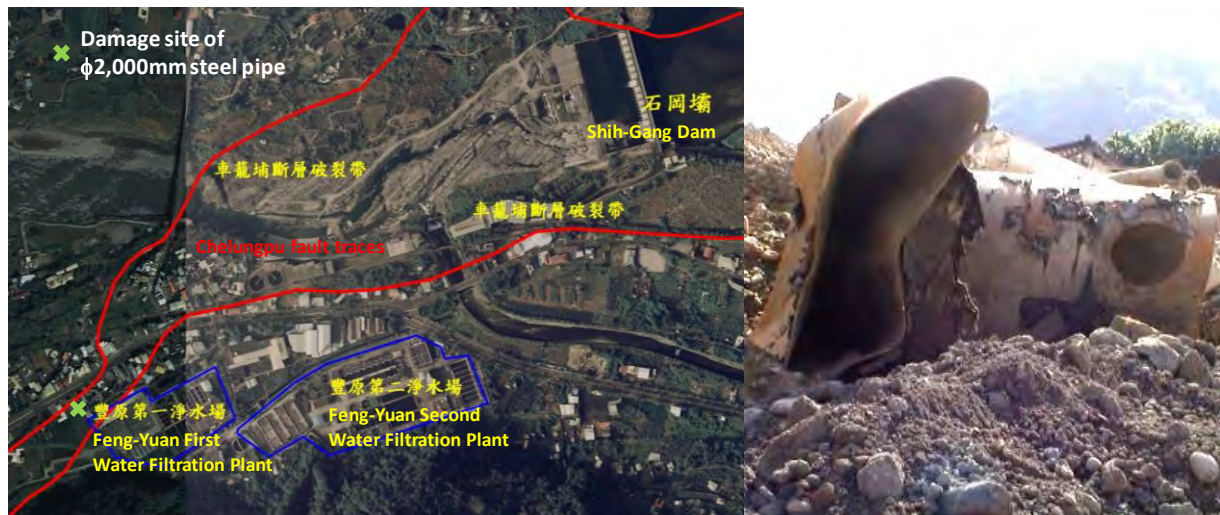
Figure 1 A  $\phi 2,000\text{mm}$  steel pipe bent and damaged at Chelungpu fault crossing near the Feng-Yuan First Water Filtration Plant in Chi-Chi earthquake (courtesy Taiwan Water Corp.)

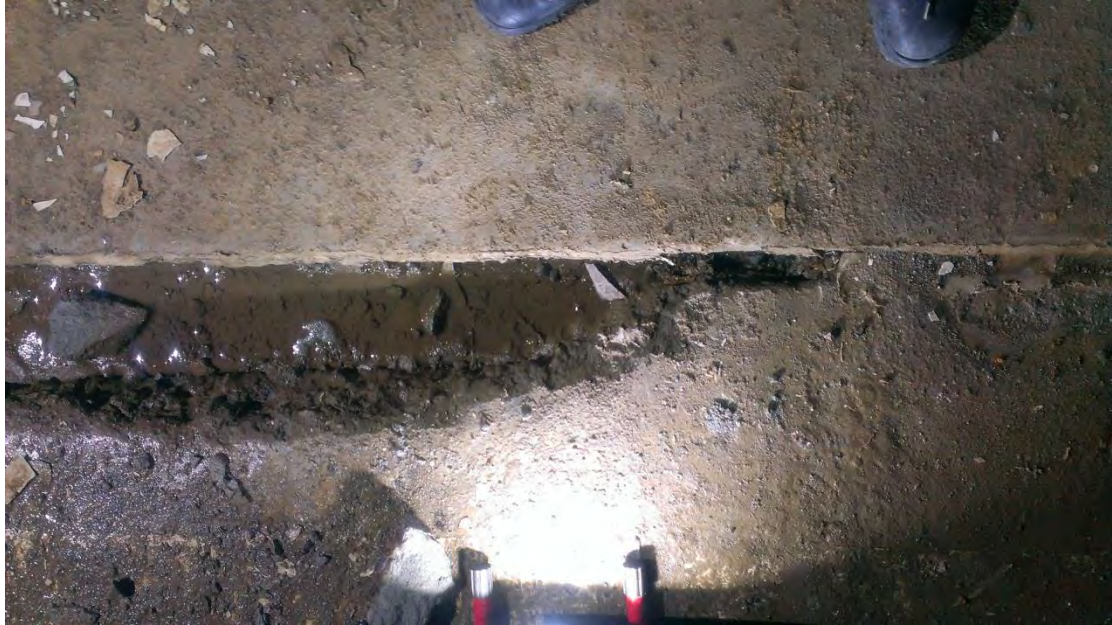
Figure 3 The crack caused by interactional bump of base plate of water tank

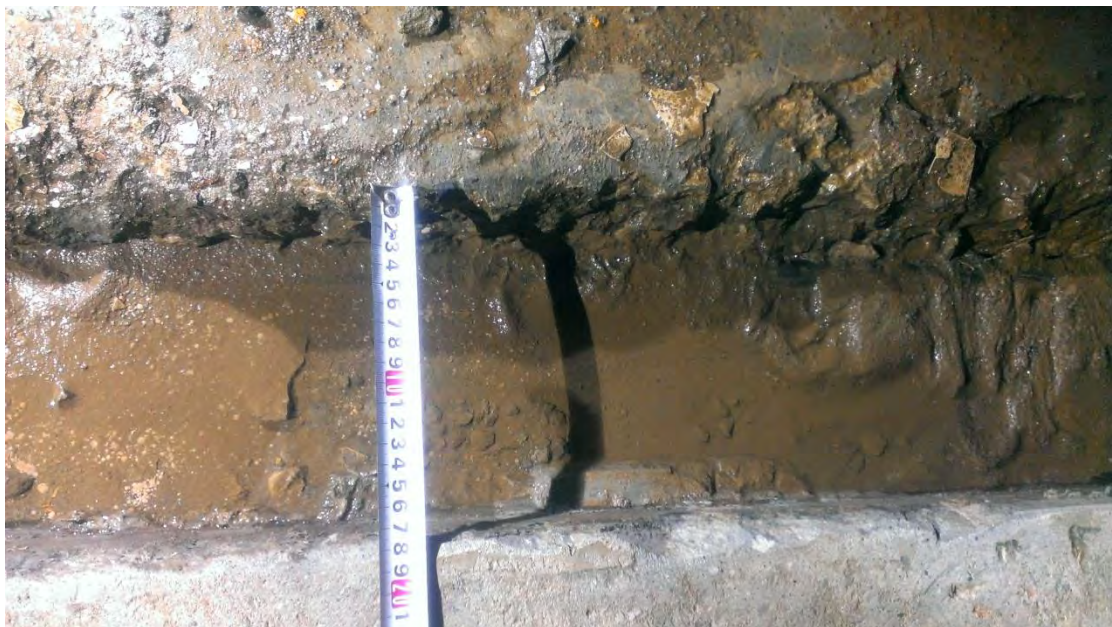
Figure 4 The expansion of the extension joint

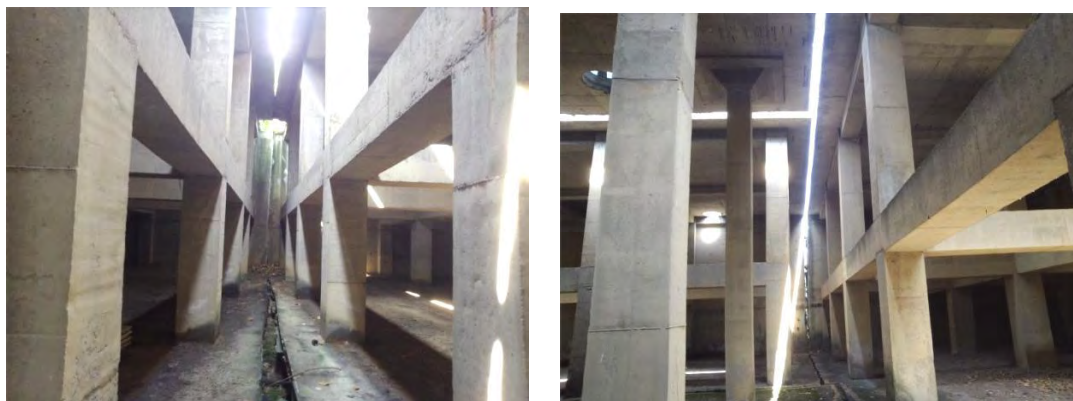
Figure 7 The severe expansion of extension joint
