# Proceedings of the 9<sup>th</sup> Water System Seismic Conference

October 14–16, 2015

Sendai, Japan

Project #4603

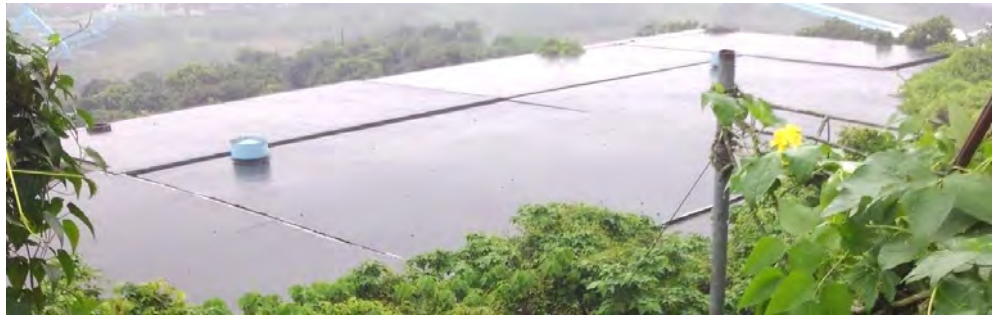
Figure 1 The roof of water tank – the failure of extension joint by expansion

The damaged extension joints can be dealt by removing the exterior of 60 cm, re-placing the waterproof material, re-smearing silicon that is elastic and waterproof, placing three layers of glass fabrics, smearing silicon again, placing the rubber mat, placing stainless steel plate and then fixing the stainless steel plates with expansion screws.

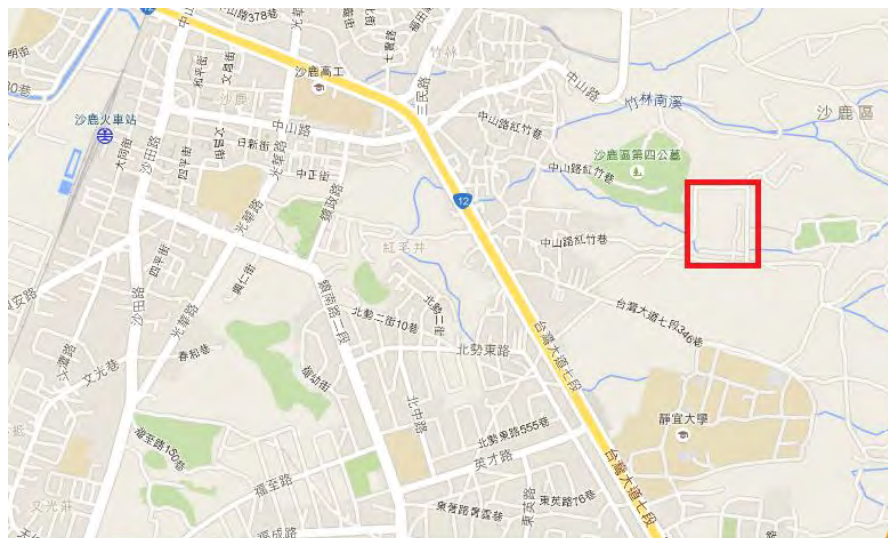
At present, the reservoir is located nearby the forth public cemetery and Providence University in Shalu Dist., Taichung City. It is away from the Tuntzuchio fault approximately 2.623 KM, which was constructed in 1990 (The project of water distribution center in the specific district of Taichung Harbor). The overall sizes are 108M of length, 64M of width, 6.4M of height, about 0.8M of foundation depth, and the storage capacity is about 40,000 tons. The structure got slightly deformation and leakage, showing as figure 2.

Figure 2 the nearby of water tank

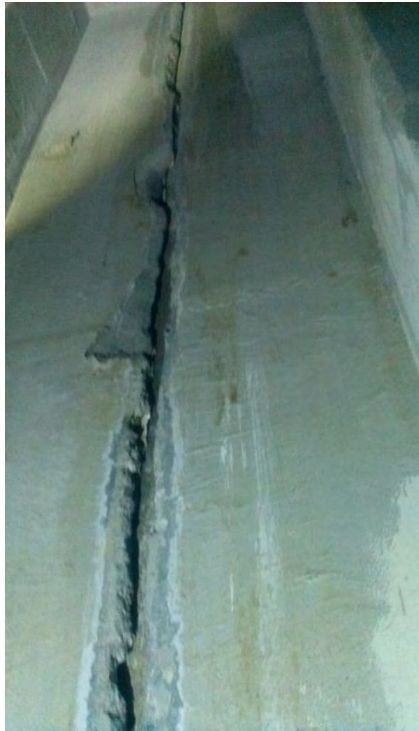
The common usage impairment is the crack of walls and plate that is caused by interactional collision, or tear impairment of extension joint caused by large displacement, showing by figure 3, figure 4 and figure 5. Moreover the combined water tank was built in early years. And the early building code which is lenient on the capacity of earthquake resistance, the joints of beam and column usually got cracking after the earthquake, showing by figure 6.

Figure 5 the crack of wall

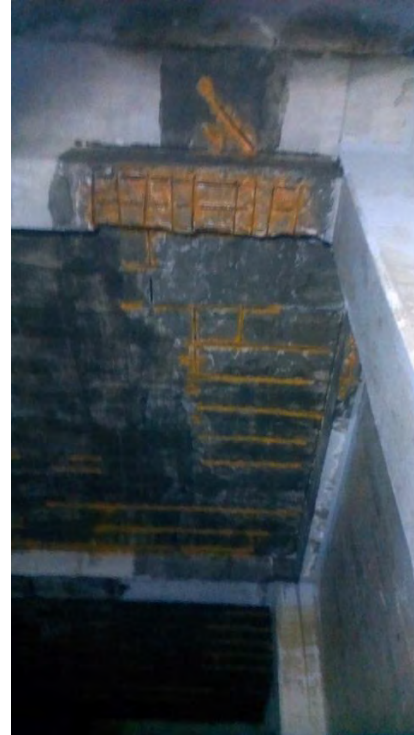
Figure 6 the crack of the joint of beam and column

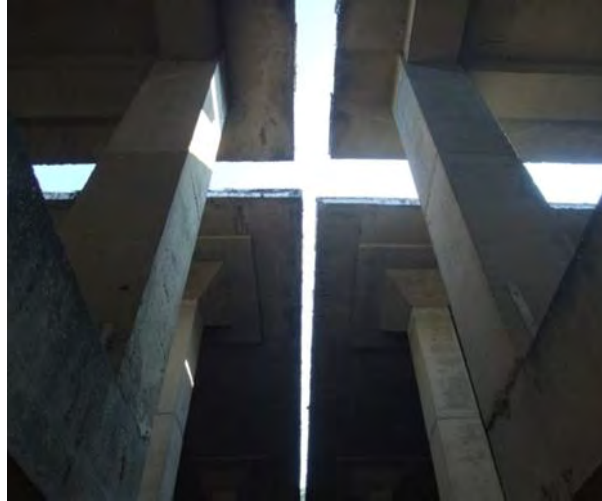
The main damage patterns of Nao-Guan reservoir are relative displacement damage produced from expansion joint and stress damage of beam-column joint, as shown picture 1-4. It can be seen that there is an obvious crack and disturbance near ground. This is because reservoir is located near geological fault zone. The maximum crack width from basin wall relative displacement is around 1 m, it can be passed through by one man. Many foundations displacement happened and then resulted in base slab rupture when there is an earthquake due to the single footing foundation was used in the tank structure. The service tank was seriously damaged and completely lost it function.

Figure 1 Split of top slab from expansion joint

Beam-column system structure of reservoir were partly damaged due to extra shear force and moment produced by foundation displacement. To remove and reconstruct a new reservoir is more possible choice because the structure was seriously damaged and the function was completely lost.

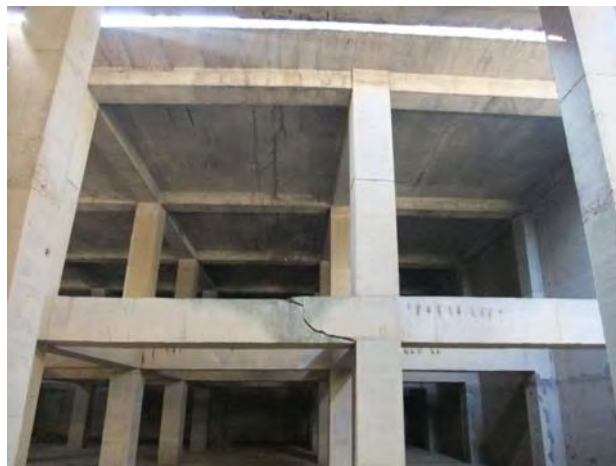
Figure 2 Break in the joint of beam-column joint

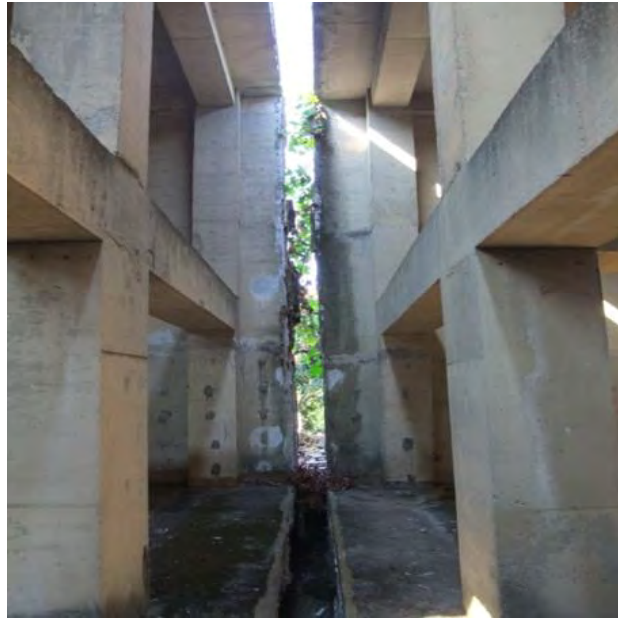
Figure 3 Split of basin from expansion joint

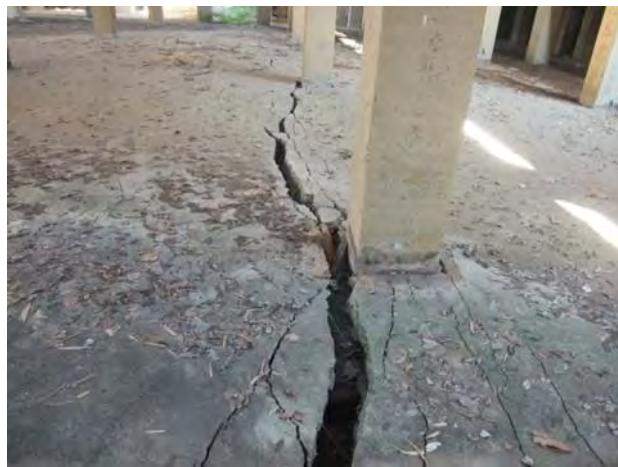
Figure 4 split of bottom slab

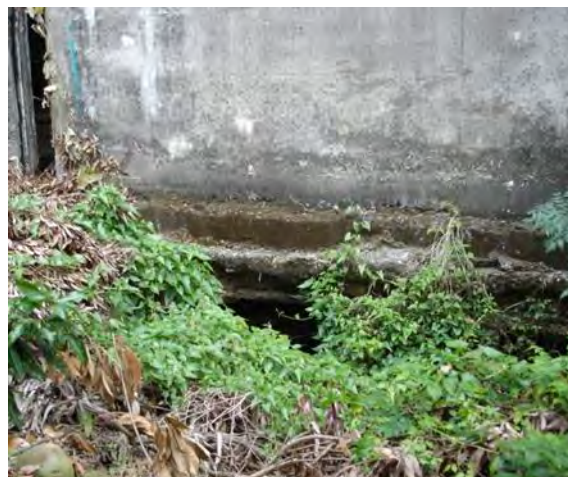
Again, from picture 6 and 7, it is shown that there is an obvious exposed stratum and ground rupture in the surrounding surface of reservoir. It can be forecasted that if reconstruct reservoir at the original site, it is very possible to have a serious damage when there is an another earthquake happened.

Figure 6 Rupture of ground in the surrounding surface of reservoir.

future operation requirement, geological feature, regulation limits and economics. After detail evaluation, repairing the damaged reservoir or reconstructing reservoir at the original site is not suitable. Finding a site to construct a new reservoir is a better proposal.

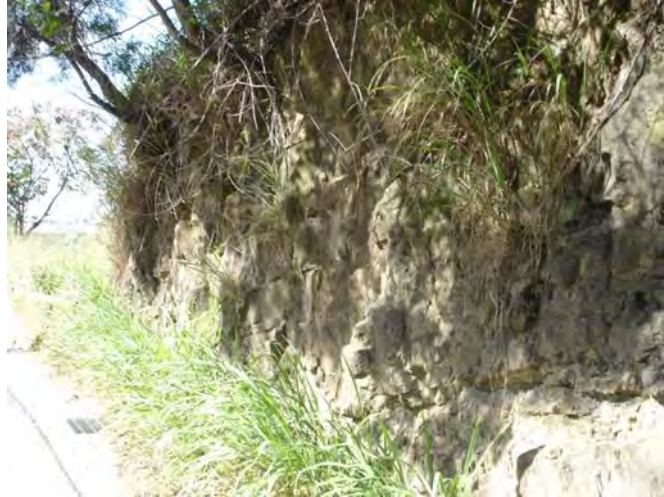
Figure 7 Obvious exposed stratum in the surrounding surface of reservoir.

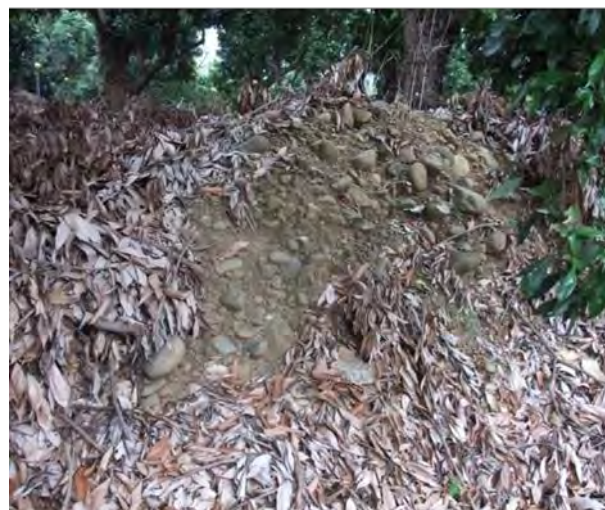
Nao-Guan reservoir is located at hillside, its elevation is 128 m. There is a 3 m pebble and gravel lay on the top of soil (Figure 10), rock characteristic is siltstone intersperse with thin shale strata (Figure 11). This rock stratum is mild to middle weathering, and stratification of stratum is still clear to be identified. The relative position of Che-Long-Pu geological fault and Nao-Guan reservoir is shown in Figure 7. From the point of geological condition view, the site of original Nao-Guan reservoir is located in active geological fault susceptible region, and it is not suitable to reconstruct reservoir in the original site.

Figure 10 A 3 m pebble and gravel lay on the top of soil

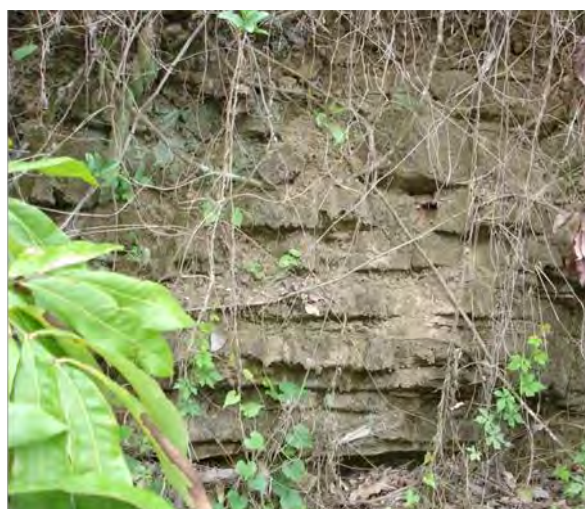
Figure 11 Siltstone intersperse with thin shale strata in the vicinity of reservoir
